**PHASE I REPORT  
NATIONAL DAM INSPECTION PROGRAM**

**NAME OF DAM:** Brookville Water Works Dam  
**STATE LOCATED:** Pennsylvania  
**COUNTY LOCATED:** Jefferson  
**STREAM:** North Fork Creek, a Tributary of Red Bank Creek  
**SIZE CLASSIFICATION:** Small  
**HAZARD CLASSIFICATION:** Significant  
**OWNER:** Borough of Brookville  
**DATE OF INSPECTION:** April 24, 1980 and April 30, 1980

BROOKVILLE WATER WORKS DAM  
NDI I.D. PA-422  
DER I.D. 33-2  
APRIL 24, 1980

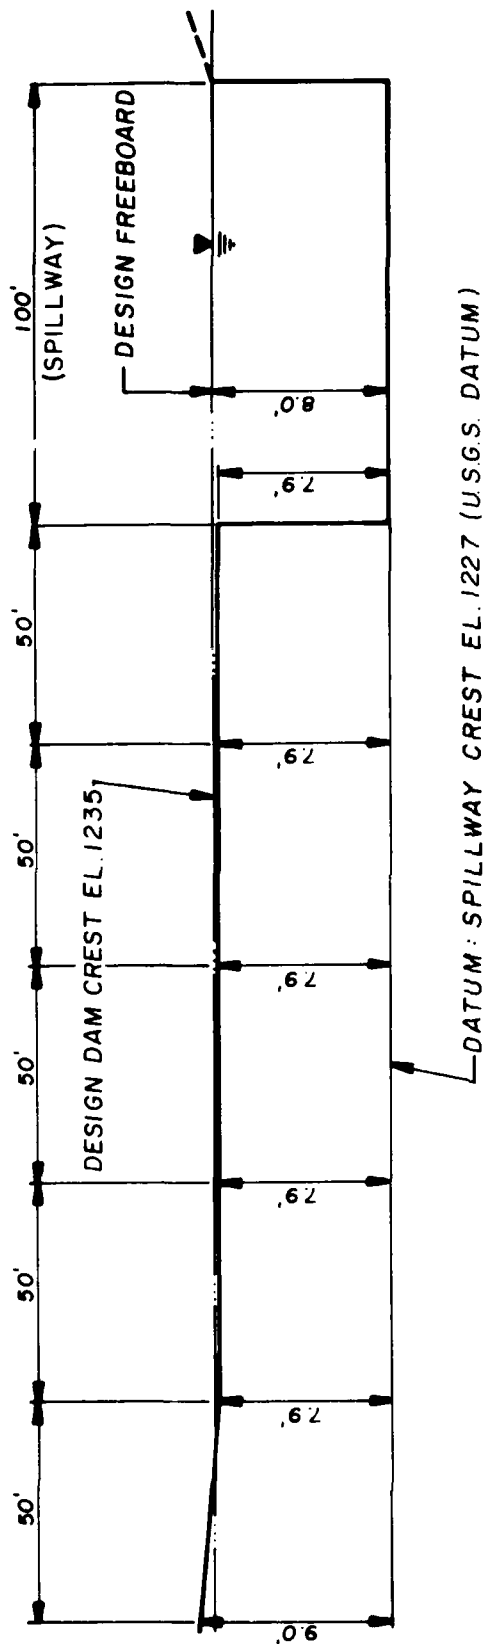
# DAM CREST PROFILE (LOOKING DOWNSTREAM)

The crest of the dam was surveyed relative to the spillway crest elevation and it was found that the dam crest was essentially at the design crest level with a minor low spot located at the right abutment embankment interface. The dam crest profile is illustrated in Plate 6. The downstream and upstream slopes were surveyed and were found to be reasonably within the design slope of 2H to 1V.
